INDOOR AIR QUALITY ASSESSMENT

**Massachusetts Division of Health Care Finance & Policy
China Trade Building
2 Boylston Street
Boston, Massachusetts**

Prepared by:
Massachusetts Department of Public Health
Center for Environmental Health
Emergency Response/Indoor Air Quality Program
May 2005

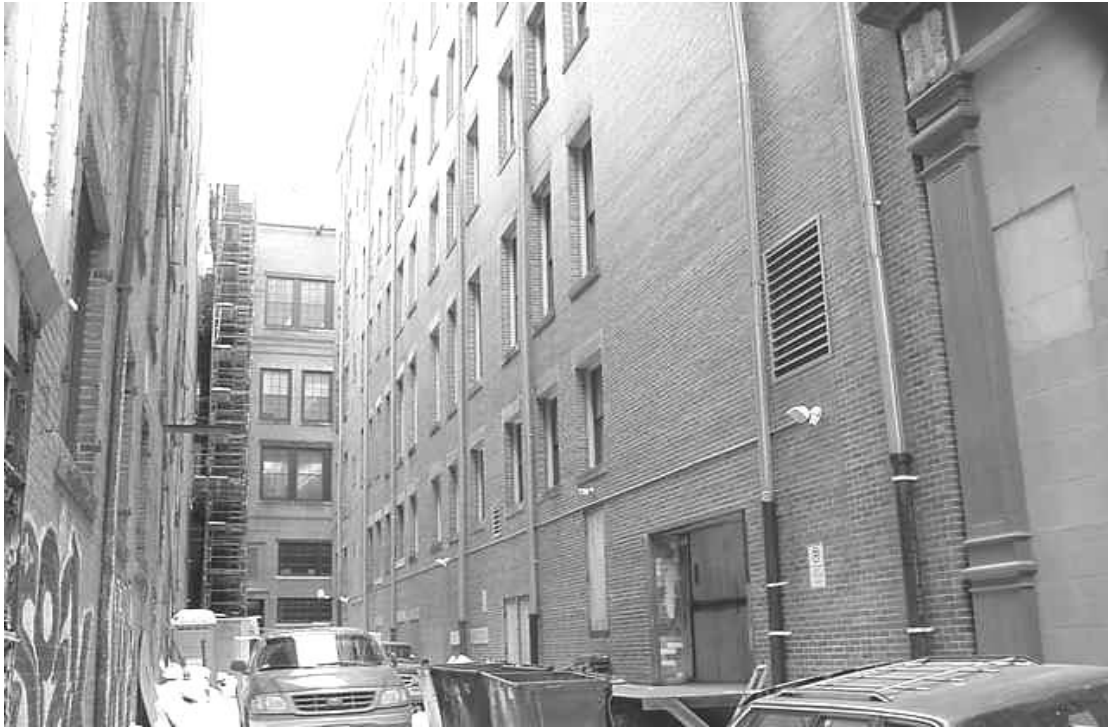
Picture 1

The CTC was originally constructed in the early 1900's. An addition was built on the alleyway side of the building in the 1980s (Picture 1) as part of an overall rehabilitation of the building. At that time, a large multi-story atrium was also added to the building (Picture 2). The ground and first floor are occupied by a variety of commercial business. Floors three through six serve as office space for Massachusetts state agencies. The division of DHCFP occupies the entire fourth and fifth floors and limited space on the sixth floor. The DHCFP office space consists of numerous private offices as well as cubicles created by floor dividers. Windows are openable throughout the DHCFP offices examined.

Addition to Rear of Building

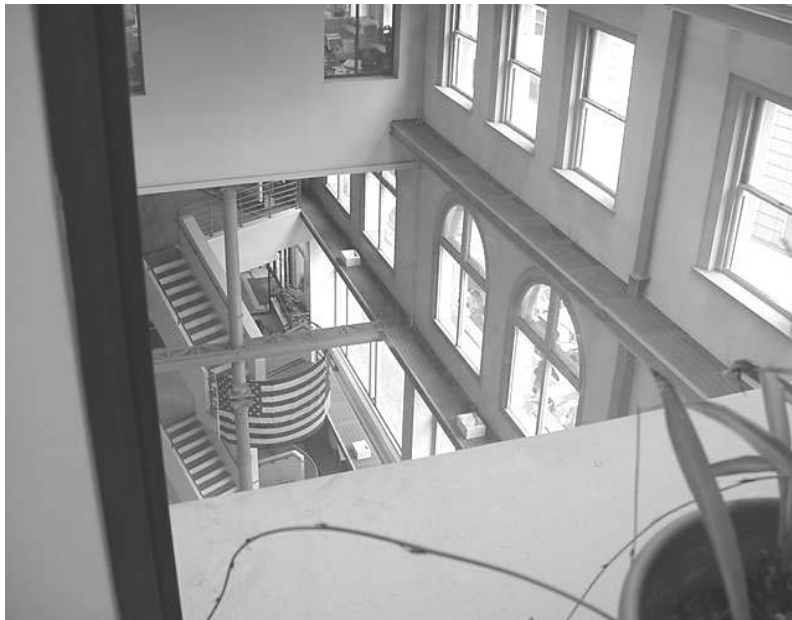
Picture 2

Atrium inside the Building

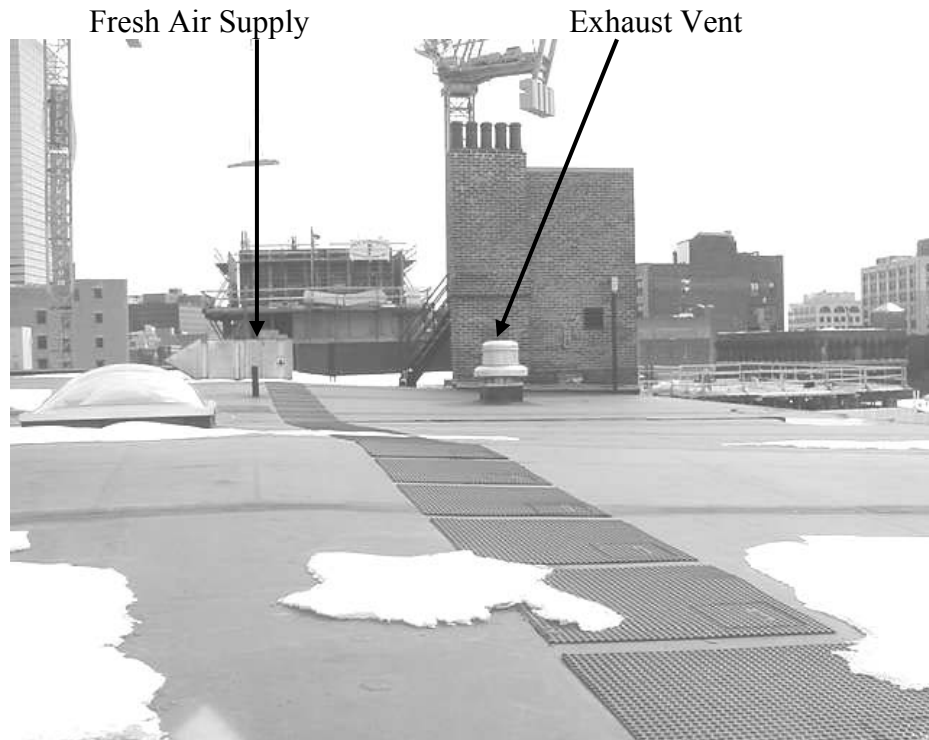
Picture 3

An exhaust motor for restrooms was observed on the roof (Picture 3). The rooftop AHU was also examined and did not appear to have any means for exhaust air. No other means of mechanical exhaust ventilation could be identified on the roof. Therefore, it appears that the sole method to mechanically exhaust air from the building is via the restroom vents. Each restroom is equipped with one ceiling-mounted exhaust vent. The restroom doors are equipped with a transfer air vent, which draws air from the hallway. Restrooms are located in a central area on each floor, which would facilitate the draw of air from hallways, and indirectly cubicle areas and offices. This design provides limited exhaust ventilation and can allow common indoor pollutants (e.g., carbon

dioxide exhaled from occupants, odors from cooking appliances) to build-up inside the building and be continuously recirculated by the heat pumps leading to indoor air/comfort complaints.

Rooftop AHU and Likely Restroom Exhaust Fan On Roof

3. Identify the means by which the general ventilation system exhausts air from the building and operate the system during business hours. If no means to provide general exhaust ventilation exists, consult a ventilation engineer on the most appropriate method to install a general exhaust ventilation system and move forward with installing this equipment.

5. Examine feasibility of providing exhaust ventilation for break rooms with cooking appliances.
6. Ensure restroom exhaust vents are operating during business hours to remove odors and excess moisture.

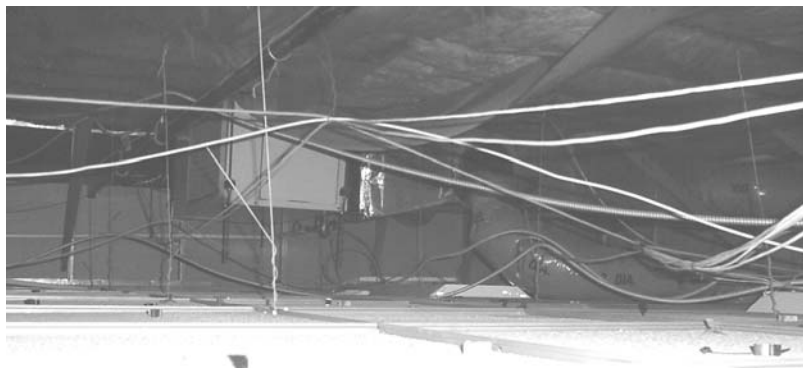
Picture 4

As mentioned previously, findings and recommendations pertaining to renovation activities were detailed in a previous letter issued by MDPH (MDPH, 2005). Several other conditions that can affect indoor air quality were also identified. Of particular note is the configuration of the ventilation system. The HVAC system uses a ceiling plenum system to return air to heat pumps located above the suspended ceiling (Picture 4). Air is returned to the heat pump via the space between the suspended and original ceilings (a ceiling plenum). As the heat pump operates, air is drawn into the pump through the ceiling plenum, which in turn depressurizes the plenum to draw air from the occupied spaces through return grilles in the ceiling.

Ceiling Plenum above Suspended Ceiling

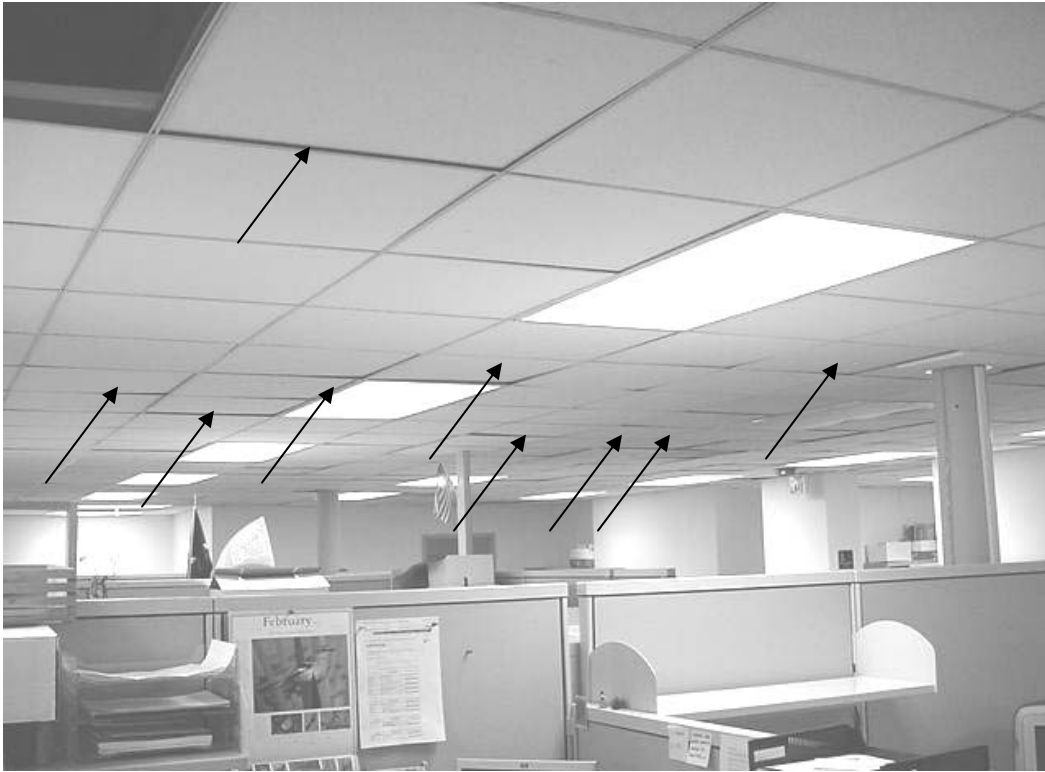
Picture 5

The suspended ceiling consists of ceiling tiles that are made of foam polystyrene, an extremely light plastic material. In most areas examined, ceiling tiles were dislodged from the ceiling supports (Picture 5 and 5a) by either the draw of air by the heat pumps or by pressurization of the occupied space when windows are open. The dislodgement of ceiling tiles is most likely due to the lightweight ceiling tile materials, which do not have the same weight as typical cellulose ceiling tiles to hold them in place. Dislodged tiles/breaches in the ceiling tile system decrease the efficiency of the plenum system to draw air, which can produce uneven heating/cooling leading to temperature/comfort complaints.

Dislodged Ceiling Tiles

7. Consideration should be given to replacing foam polystyrene ceiling tiles with a heavier type in order to help maintain the integrity of the ceiling plenum system.

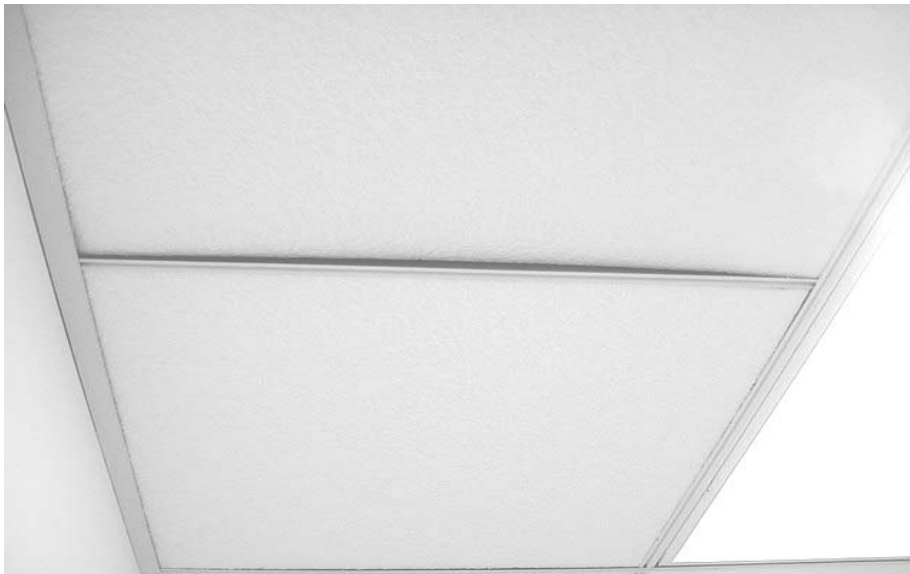
Picture 5A

Close-up of Dislodged Ceiling Tile

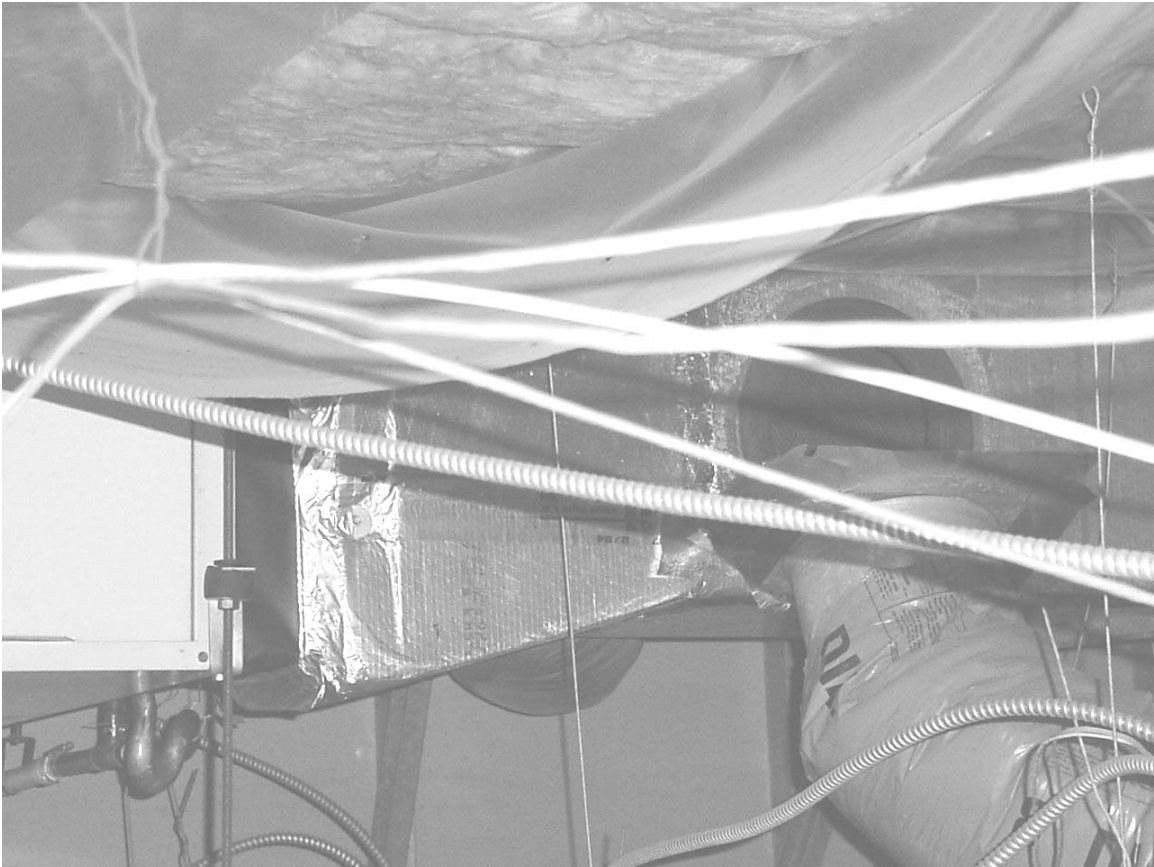
Picture 6

A variety of locations of the ceiling plenum were examined. Open penetrations in the original ceiling were noted. Since the heat pumps depressurize the ceiling plenum, materials (e.g., particulates, odors) above the original ceiling or wall space can then be drawn into the plenum and distributed into occupied areas by the heat pump. Ceiling plenums should be sealed as much as practicable in order to prevent this occurrence. Each heat pump is connected to an air diffuser by a flexible duct that is connected to a rigid, metal duct. The plenum above the sixth floor bullpen area was examined due to noise above the ceiling. In the area of the noise, flexible ductwork was

dislodged from the metal supply duct (Picture 6). This disconnection prevents distribution of air to this area and may account for the vibrating noise.

**Flexible Supply Air Duct Disconnected From Metal Duct
In Sixth Floor Ceiling Plenum**

1. Implement the recommendations made in the March 16, 2005 letter.
2. Examine the ceiling plenum for disconnected flexible ductwork on each floor and repair as needed.
